INDOOR AIR QUALITY ASSESSMENT

**Hiram L. Dorman Elementary School Annex
20 Lydia Street
Springfield, Massachusetts**

Prepared by:
Massachusetts Department of Public Health
Bureau of Environmental Health Assessment
August, 2002

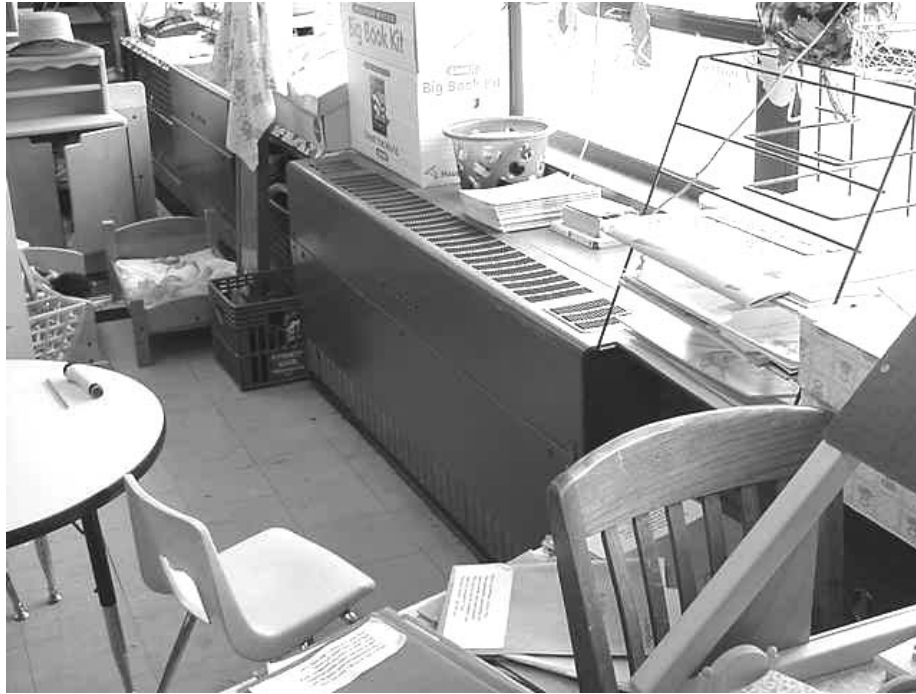
Picture 1

Fresh air in the DESA is provided by a unit ventilator (univent) system of a design dating back to the original construction of the building (see Picture 1, [Figure 1](#)). Within each univent is a fan. In order for univents to function as designed, univent fresh air diffusers and return vents must be unblocked and remain free of obstructions. Importantly, these units must be activated and allowed to operate.

DESA Univent

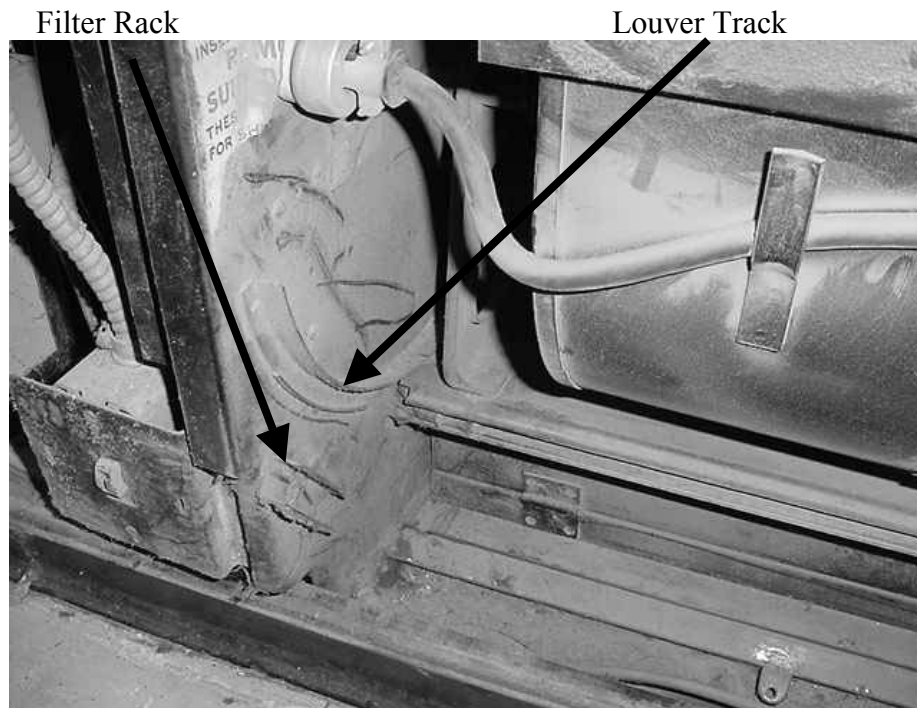
Both the radiator and univent were opened and examined in classroom 17. Airflow into the univent is controlled by a pendulum louver (see Picture 2). The position of the louver determines the amount of fresh to return air from the classroom. The louver in Picture 2 is fixed in the closed position, preventing fresh air intake by the univent.

Assuming that this univent is representative, the ventilation system is not able to draw fresh air from outdoors. The sole means for introducing fresh air into this building is through opening windows.

Univents did not contain filters, despite the presence of a filter rack (see Picture 2). The interiors of both the univent (see Picture 8) and radiator (see Picture 9) are coated with accumulated dust, dirt and other debris. In order to avoid serving as a source of aerosolized particulates, the air handling sections of the univents should be regularly cleaned. However, without filters, dirt, dust and debris can easily collect within the units. In this condition, dust, dirt and other debris can be introduced/re-aerosolized by the ventilation system. In order to decrease aerosolized particulates, disposable filters with a high dust spot efficiency should be installed. The dust spot efficiency is the ability of a filter to remove particulates of a certain diameter from air passing through the filter. Filters that have been determined by ASHRAE to meet its standard for a dust spot efficiency of a minimum of 40 percent would be sufficient to reduce airborne particulates (Thornburg, 2000; MEHRC, 1997; ASHRAE, 1992). Note that increased filtration can reduce airflow produced by the unit due to increased resistance (called pressure drop). Prior to any increase of filtration, each univent should be evaluated by a ventilation engineer to ascertain whether it can maintain function with higher efficiency filters.

Pendulum Track For Louver, Note Filter Frame Stays of Cabinet Wall

1. Do not store mops in standing water. Drain and dry mops and mop buckets after use. Discard moldy mop heads.
2. Pour water into the sink and floor drains twice a week to maintain the airtight seal.
3. Examine each univent for function. Survey classrooms for univent function to ascertain if an adequate air supply exists for each room. Consider consulting a heating, ventilation and air conditioning (HVAC) engineer concerning the restoration of univent fresh air control dampers throughout the school.
4. Remove all blockages from univents to ensure adequate airflow. Clean interiors of univents regularly.

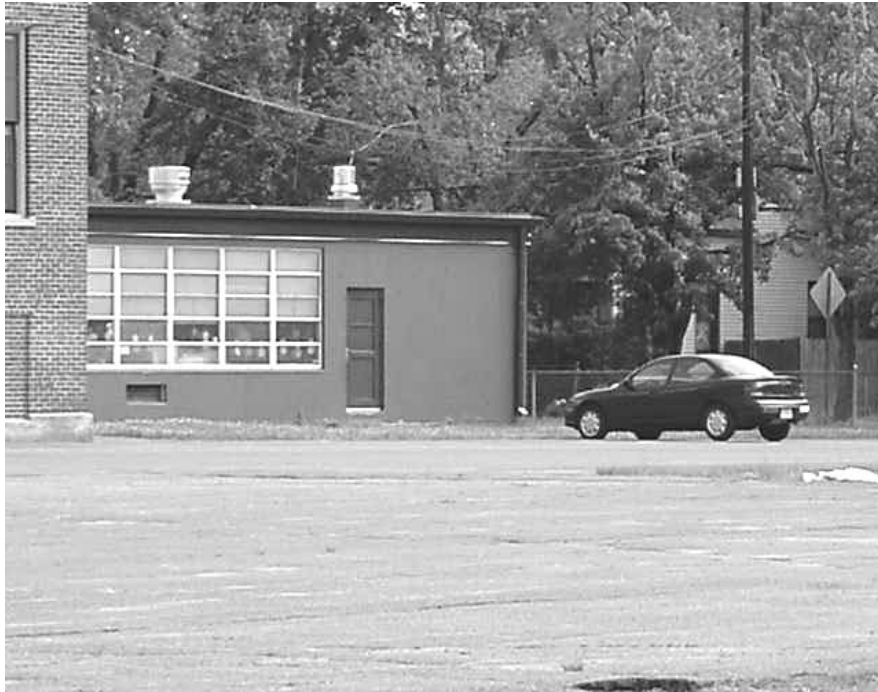
Picture 3

An exhaust vent exists in each classroom, which consists of a grill installed in a metal duct connected to recently installed rooftop exhaust vents (see Picture 3). Both classroom exhaust vents were operating.

Exhaust Vents On DESA Roof

5. Clean accumulated debris from exhaust vent louvers.
6. To maximize air exchange, the BEHA recommends that the ventilation system operate continuously during periods of school occupancy independent of classroom thermostat control.

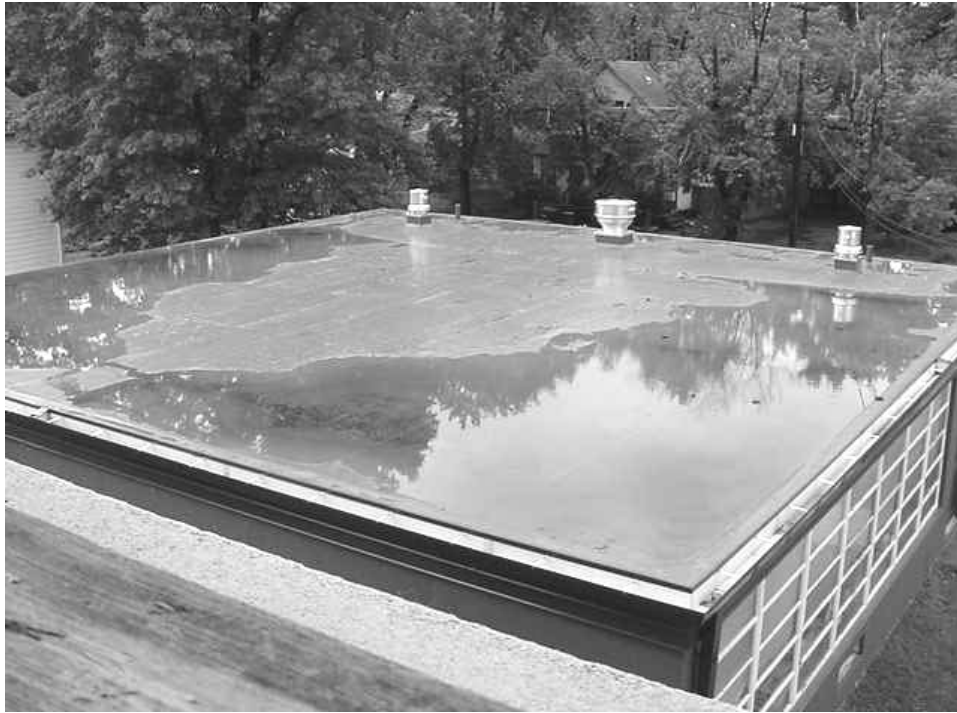
Picture 4

The design of the roof makes it prone to developing water leaks. The DESA has a flat roof covered with a rubber membrane. No roof drains appear to have been installed in the roof, nor does it appear that the roof has a pitch (see Picture 4). Water is allowed to accumulate on the roof. Once a certain amount of water has pooled, the excess spills over the roof edge into a gutter system. The accumulation of water on the roof can lead

to premature wear and create leaks in seams during the freezing and thawing cycle during cold weather.

Accumulated Water On DESA Roof, Note Dry Gutter At Edge Of Roof Indicating Minimal Drainage

1. Considerations should be given to installing roof drains in the center of the largest amount of water accumulation on the roof. If not feasible, building a pitch into the level of the roof to aid drainage when roof is replaced.

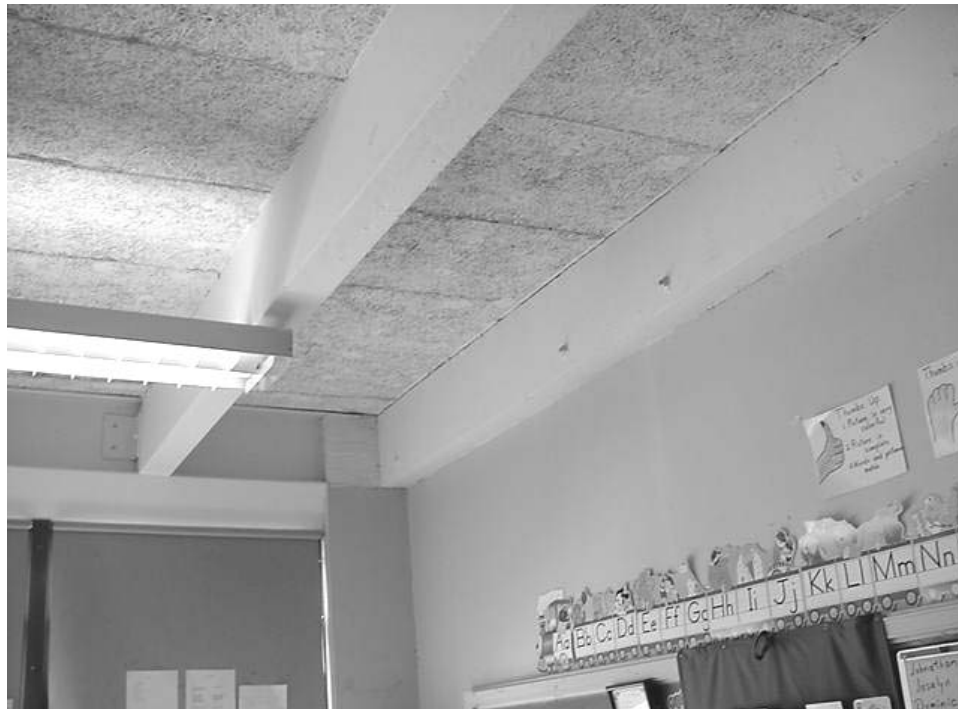
Picture 5

Water-damaged ceiling tiles were observed, which indicates a current or historic water penetration problem. Building staff reported an extensive water leak history from the ceiling in the building, which was alleviated with the installation of a new roof. Replacement of the ceiling tiles is difficult, since their removal appears to necessitate the destruction of the tile (see Picture 5), which can result in the aerosolization of particulates. Water-damaged ceiling tiles may provide a medium for mold and mildew growth and should be replaced after a water leak is discovered and repaired.

Ceiling Tiles Adhered To Ceiling In DESA

2. Water-damaged ceiling tiles should be replaced. These ceiling tiles can be a source of microbial growth and should be removed. Sources of water leaks (e.g., window frames and roof) should be identified and repaired. Examine the non-porous surface beneath the removed ceiling tiles and disinfect with an appropriate antimicrobial.

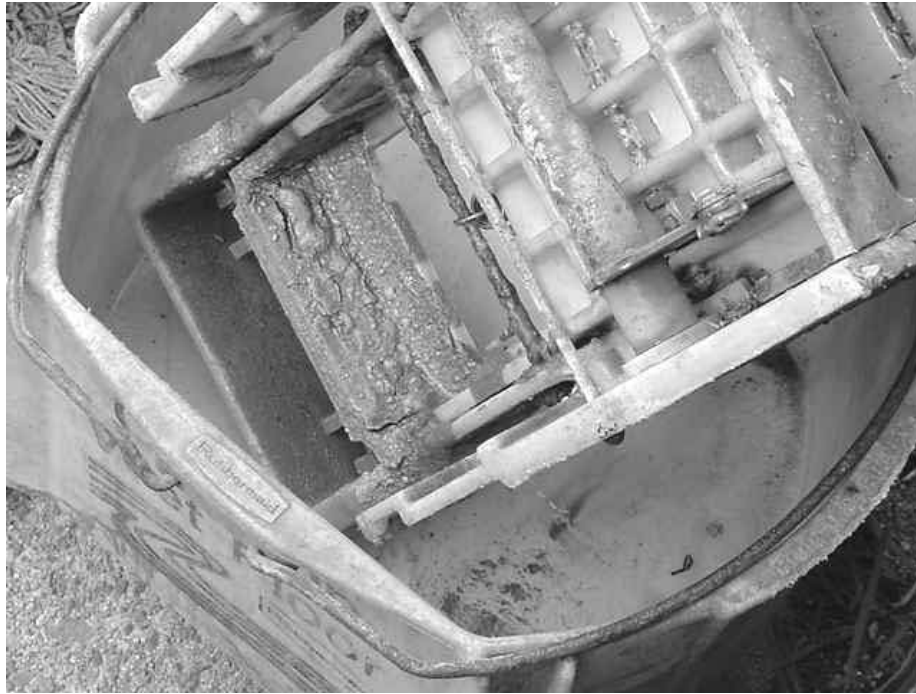
Picture 6

A pungent mold odor was detectable in the back of room 17. The odor was traced to the closet, which contained a bucket with standing water and a wet mop. A heavy coating of biofilm (microbial growth) was noted within the mop bucket (see Picture 6). Once this bucket was removed from the restroom, the intensity of the pungent odor decreased, but was not eliminated. Both standing water and wet mops can serve as mediums for mold growth. Mop buckets should be emptied and dried after use. Mop heads should be dried as soon as practicable to prevent mold growth.

Interior of Bucket Stored in Room 17

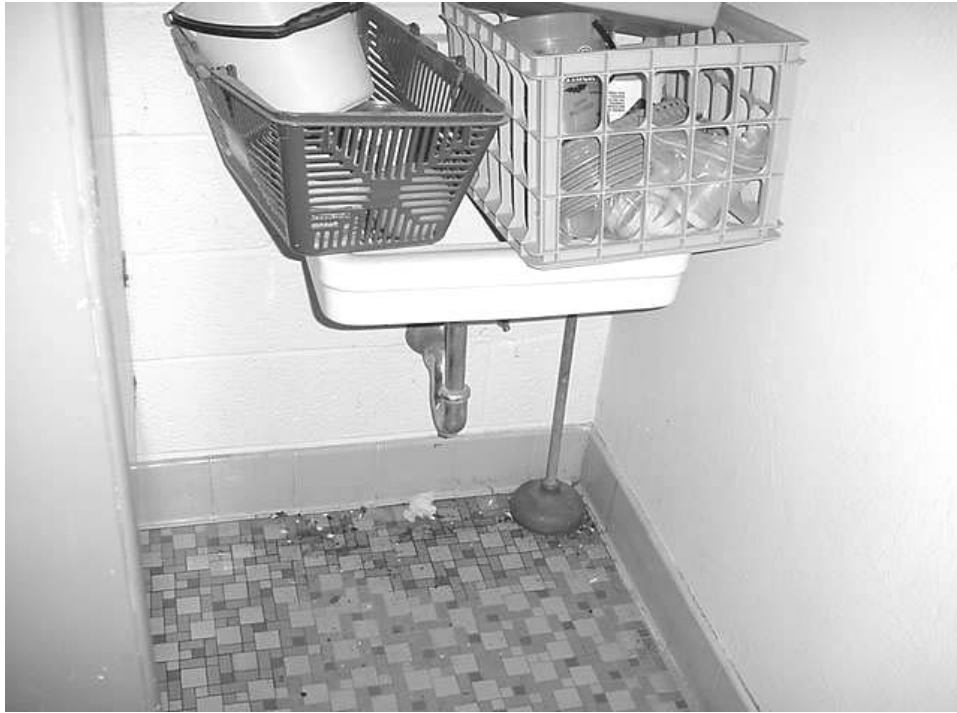
Picture 7

A number of other conditions that can potentially affect indoor air quality were also observed. Another possible source of odor detected in the rear of room 17 is the floor drain and sinks within the restrooms. Staff reported that restroom sinks are not used (see Picture 7). In addition, the floor drain traps of the restrooms appeared to be dry. A trap forms an airtight seal when water is poured down the drain. A dry trap can allow for

sewer gas to back up into the building. Sewer gas can be irritating to the eyes, nose and throat. After water was poured into the floor and sink drain, the pungent odor dissipated. Without a wet trap, the depressurization created by the exhaust ventilation system can draw air from the drainpipes and connected sewer system.

Materials Stored On Room 18 Restroom Sink

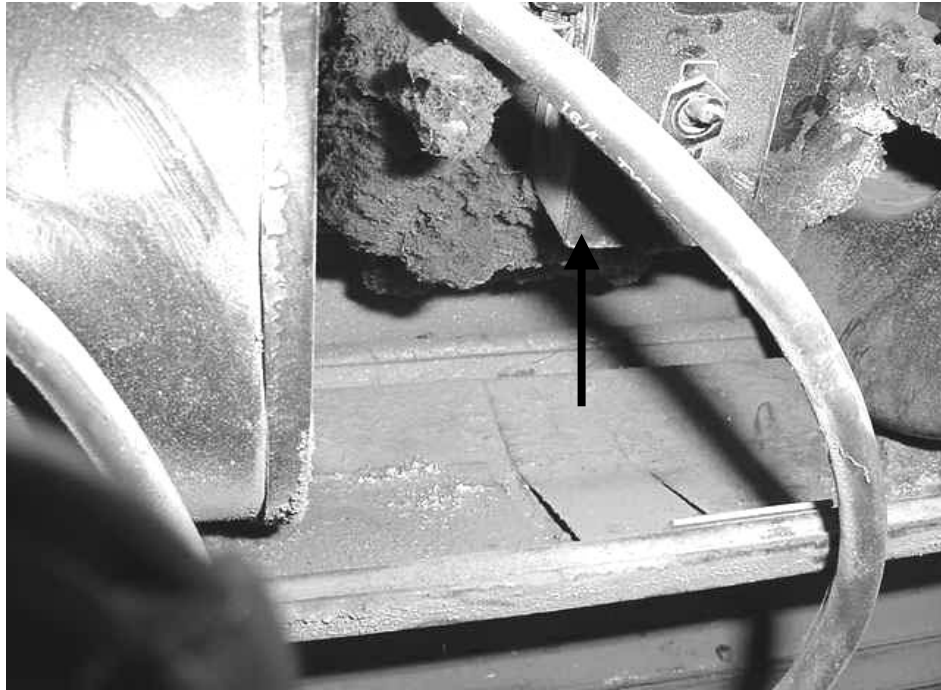
Picture 8

Accumulated Dust on Motor for Fans Inside Univent of Room 17

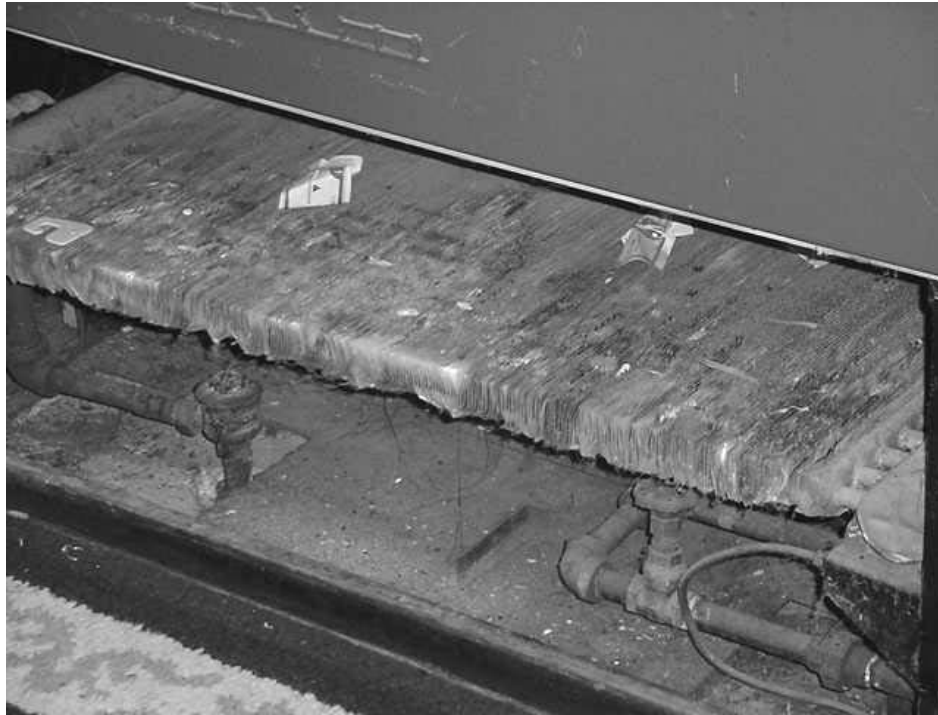
Picture 9

Radiator Coils Inside Cabinet of Room 17
